**BROWNFIELD
SOLUTIONS LTD**

STEWART MILNE HOMES

NEW BRIGHTON ROAD, MOLD

Geo-Environmental Assessment Report

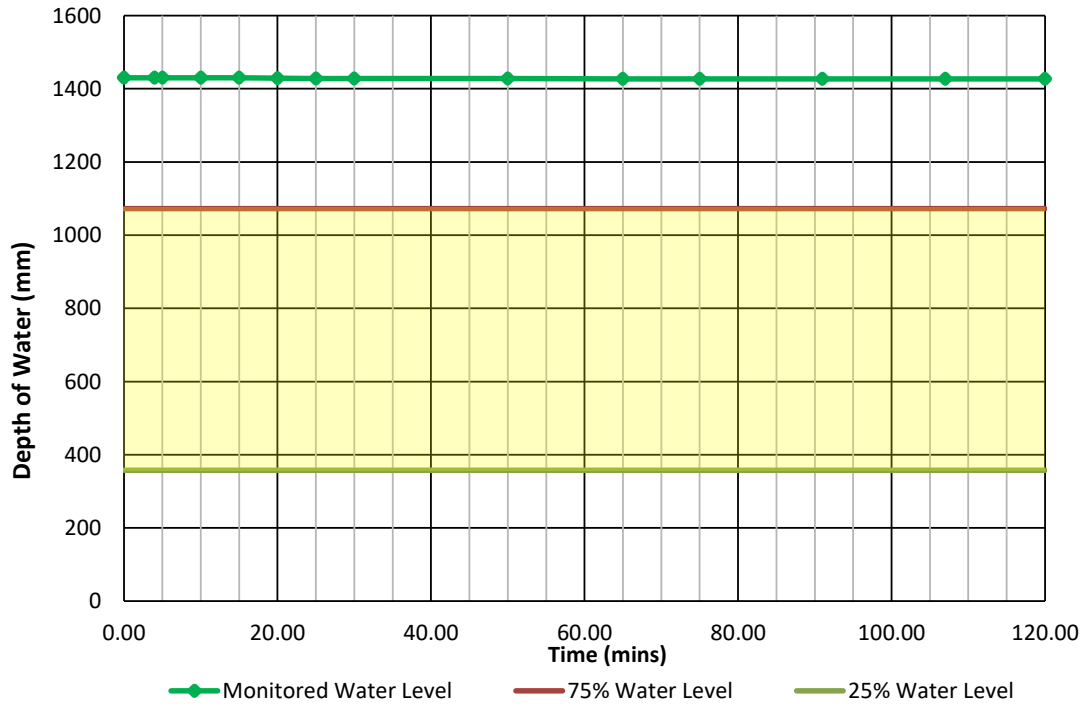
Graph of Depth vs Time

Water Level 1 (mm)	1430
Water Level 2 (mm)	1427
Time to Drain from Level 1 to Level 2 (mins)	120
Volume of water discharged (m ³)	0.00612
Discharge Area (m ²)	13.468
Soil Infiltration Rate (m/min)	3.78675E-06
Soil Infiltration Rate (m/sec)	6.31E-08

Location	Infiltration Rate (m/sec)
SA01	6.31x10 ⁻⁸
SA02	2.18x10 ⁻⁶
SA03	1.90x10 ⁻⁶
SA04	6.94x10 ⁻⁷
SA05	6.09x10 ⁻⁸
SA06	1.12x10 ⁻⁶
SA07	3.19x10 ⁻⁷
SA08	1.11x10 ⁻⁶

6.8.1 Based on the low rates of infiltration obtained, soakaway drainage will not be feasible for the site.

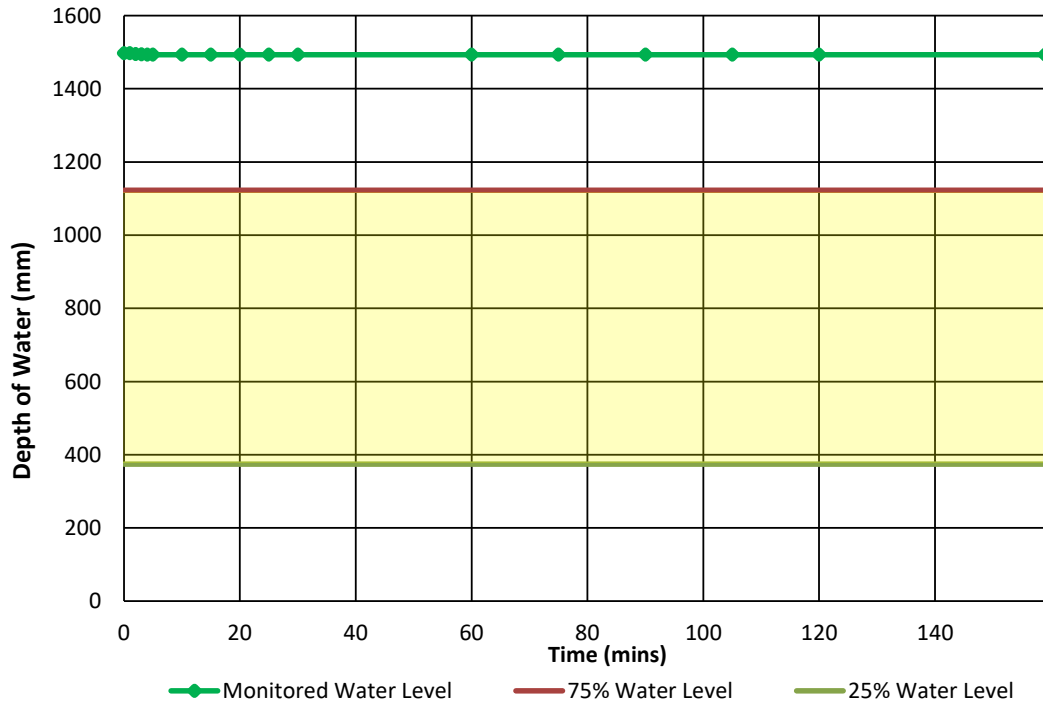
Graph of Depth vs Time

Water Level 1 (mm)	1497
Water Level 2 (mm)	1493
Time to Drain from Level 1 to Level 2 (mins)	159
Volume of water discharged (m ³)	0.00792
Discharge Area (m ²)	13.641
Soil Infiltration Rate (m/min)	3.65159E-06
Soil Infiltration Rate (m/sec)	6.09E-08

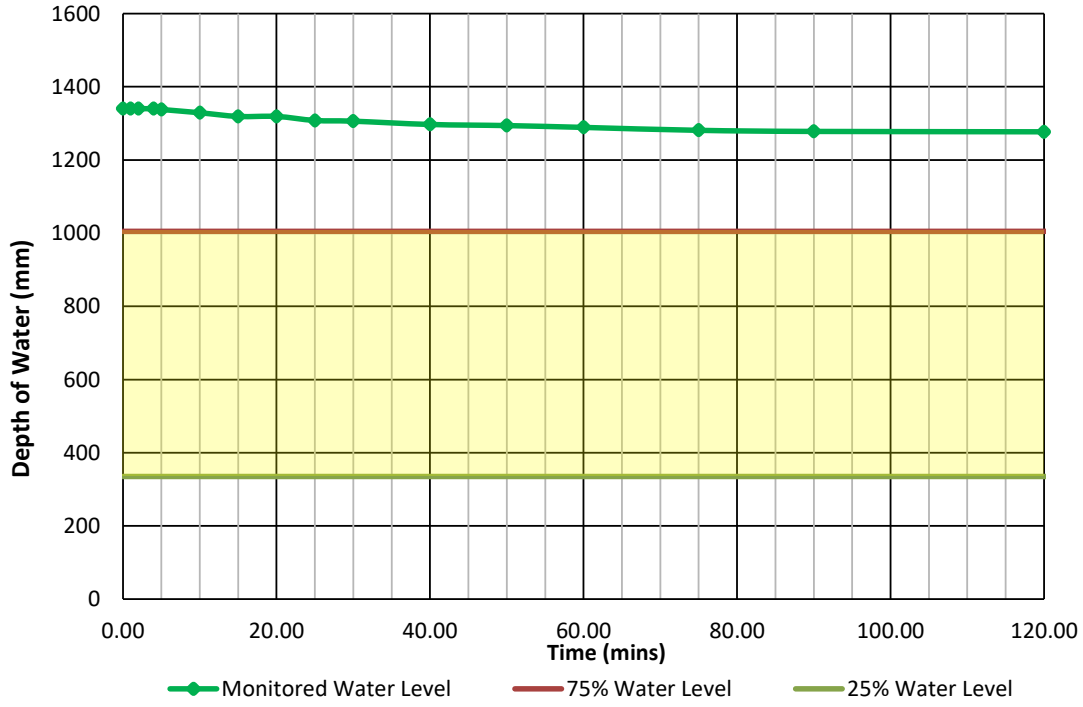
Graph of Depth vs Time

Water Level 1 (mm)	1340
Water Level 2 (mm)	1274
Time to Drain from Level 1 to Level 2 (mins)	161
Volume of water discharged (m ³)	0.1386
Discharge Area (m ²)	12.8174
Soil Infiltration Rate (m/min)	6.71641E-05
Soil Infiltration Rate (m/sec)	1.12E-06
